Safety Notice
PTI-SN-1, Rev N/C
12/18/2012

Immediate inspection of NAS1291-7/-9/-10 or MS21042L(X) nuts, for defects or failure.

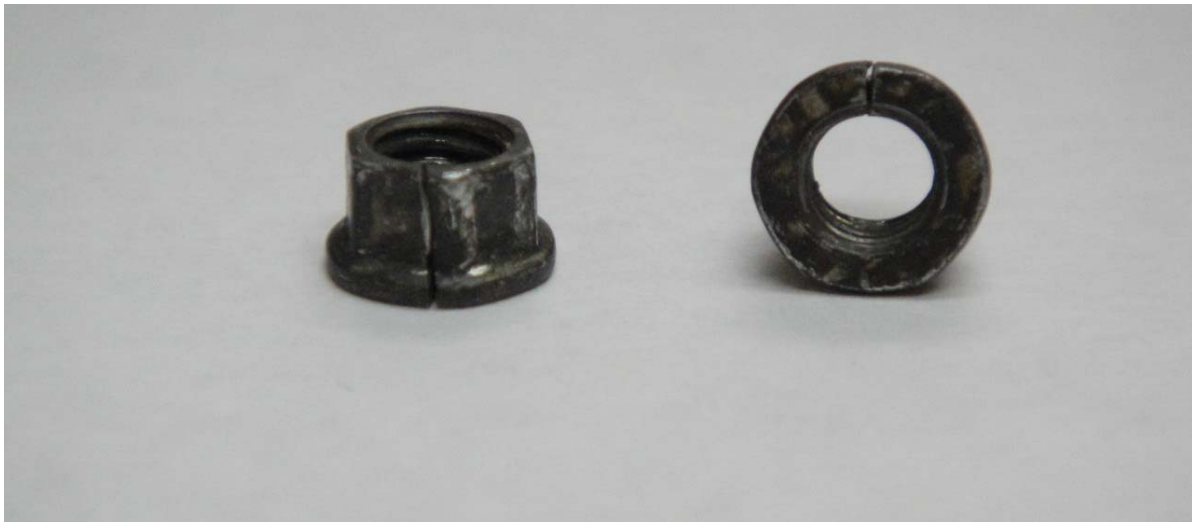
FIGURE 1

Paravion Technology Inc. recently received an imaging gimbal assembly for testing. The technician noticed incorrect hardware used to retain the gimbal to the adapter plate. Further inspection showed fatigue cracking at some of the remaining attachment hardware (reference Figure 1). Due to numerous notices from other manufacturers we highly recommend the following procedures.

Closely visually inspect hardware for surface irregularities such as gouges or cracks per the above referenced documents GEN-11-43A or SIN 2012-06R1. Replace all defective hardware before further use.
