**PARAVION TECHNOLOGY, INC.
2001 AIRWAY AVENUE
FT. COLLINS, COLORADO 80524**

**INSTRUCTIONS FOR CONTINUED AIRWORTHINESS
407LS-100 INSTALLATION**

BELL 407 HELICOPTERS

PR-407LS-120M
Revision 1, 12/19/05

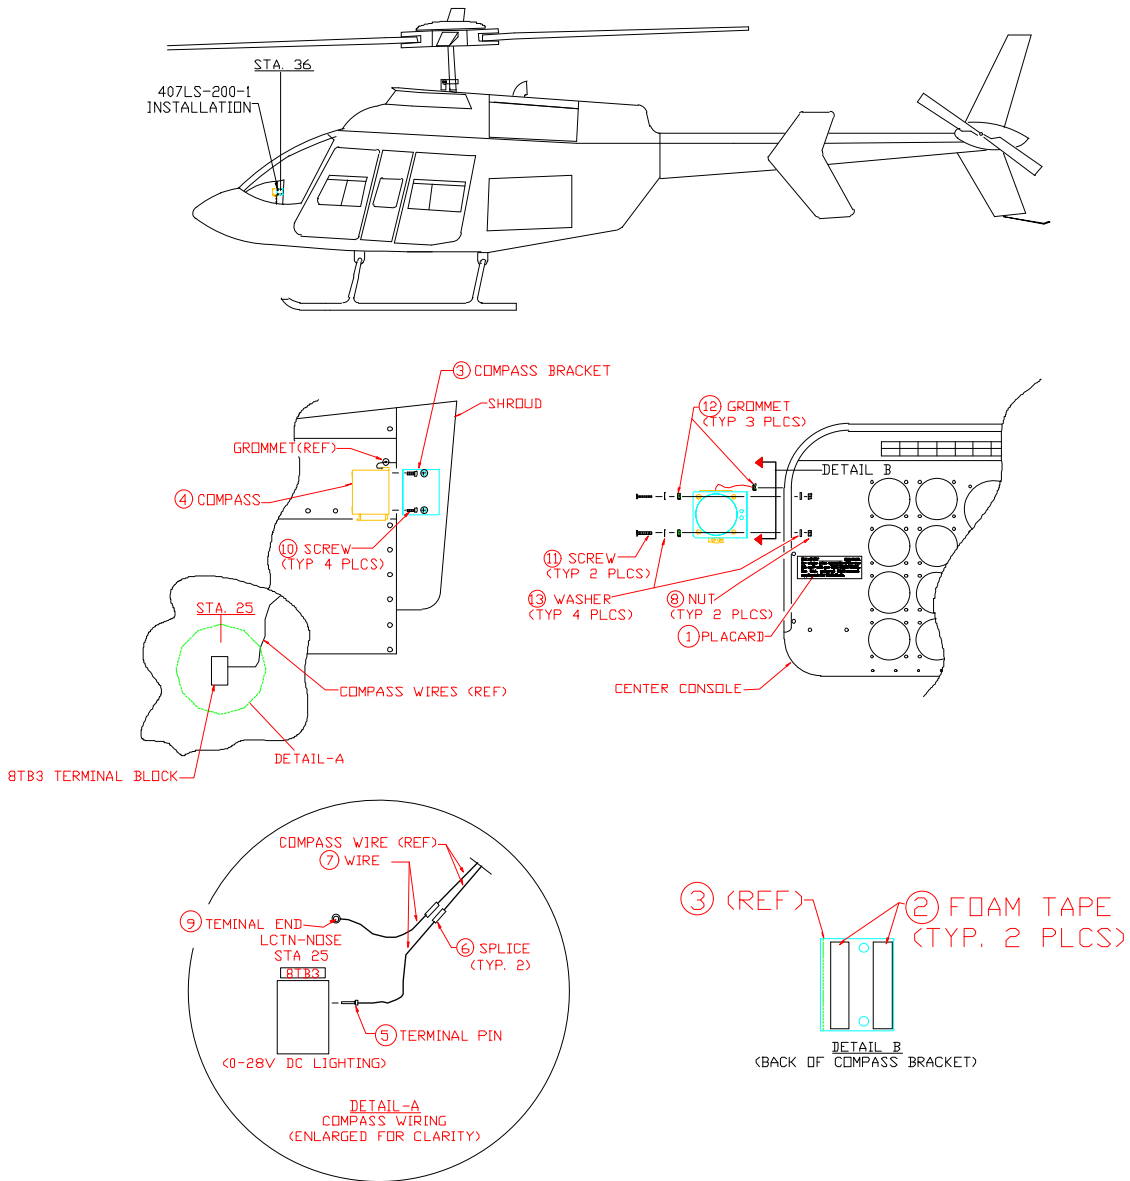
Figure 1: 407LS-200-1 Compass Installation

ITEM	P/N	DESCRIPTION	QTY	TYP
1	407LS-2000-1	PLACARD	1	EA.
2	ES06022-5	FOAM TAPE	6	IN.
3	ES59152-1	COMPASS BRACKET	1	EA.
4	ES59153-1	COMPASS	1	EA.
5	M39029/22-191	TERMINAL PIN	1	EA.
6	M7928/5-2	SPLICE	2	EA.
7	MIL-W-22759/16-22	WIRE	AS REQUIRED	
8	MS20365D632	NUT(ALT. MS21044D06)	2	EA.
9	MS25036-103	TERMINAL END	1	EA.
10	MS35214-27	SCREW	4	EA.
11	MS35214-32	SCREW	2	EA.
12	MS35489-1	GROMMET	3	EA.
13	NAS1149BN632H	WASHER	4	EA.

- 3.2.1 Insure that the power is off to the Instrument Panel Breaker.
- 3.2.2 Connect the compass wires to the 8TB3 Terminal Block and available ground lug.
- 3.2.3 Install compass assembly on the instrument panel shroud with the fastening hardware as shown in figure 2.
